Tanker Jetty, Esperance Remediation Report

Prepared for
The Jetty Group Incorporated

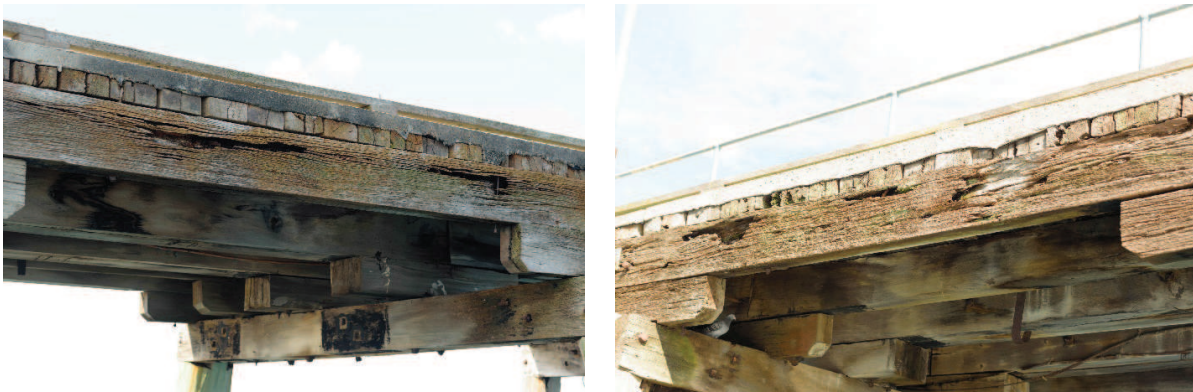
- a) That the Jetty sub-structure should only be rehabilitated with new materials, as opposed to trying to salvage the existing timber piles or headstocks for structural re-use.
- b) Several external stringers have deteriorated to the extent that they needed replacement or strength augmentation. Below are typical examples of stringer that need replacement.

Examples of typical external stringers that require replacement or structural augmentation

In total there are 48 external stringers that have been identified by myself as requiring replacement or structural augmentation. In section 9 below, I discuss the proposed stringer replacement or strengthening options.

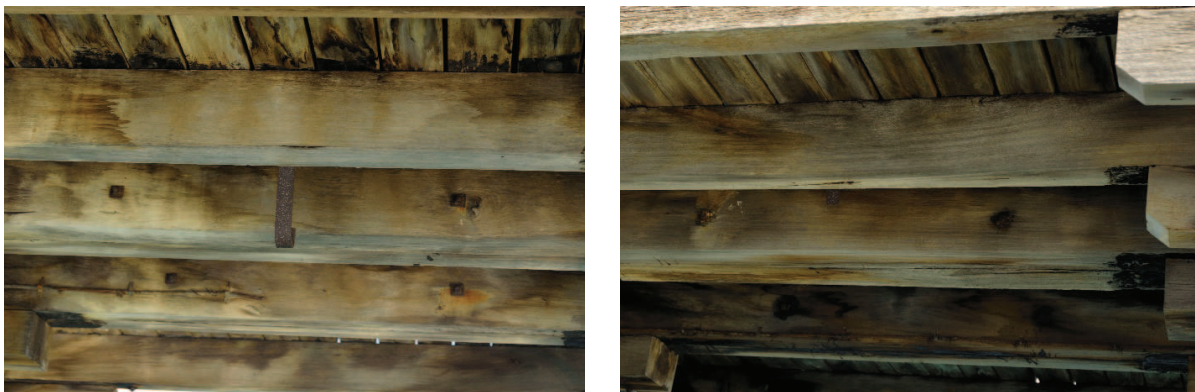
- c) The internal stringers appear to be in relatively good condition and this is most likely because they are shielded from direct sunlight and salt rich wind. Below are two images showing typical stringers.

Examples of typical internal stringers is relatively sound condition

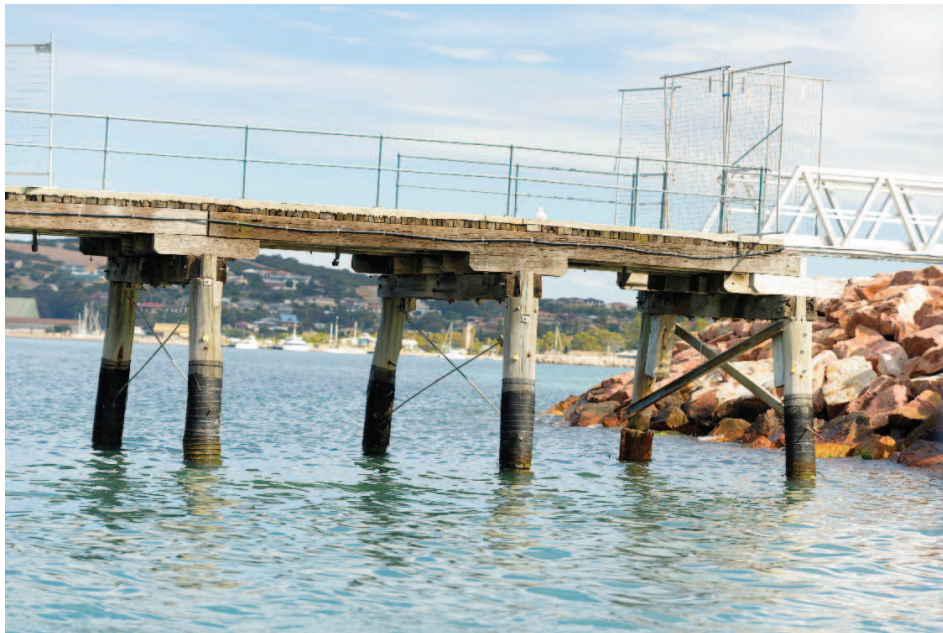
The current abutment span is a 20m long aluminium gangway onto the existing Jetty. The gangway is approximately 1.9m wide (clear), whereas the Jetty is 4.6m wide. A photo of the gangway-jetty connection is shown below. It has been assumed that this existing arrangement will remain for the baseline case, to minimise costs. However, the opportunity exists to improve upon this somewhat unattractive and relatively narrow entrance onto the Jetty. In particular, I suggest consideration be given to the design of a special feature “Entry span” constructed from or featuring original and salvaged Jetty timber. We suggest the cost of such an entry span (4.6m wide x 20m long) would be in the order of \$200,000.

Current aluminium gangway span onto the Jetty
