# Dempster Head Management Plan 2018

Prepared by  
South Coast Natural Resource Management Inc.

On behalf of  
Shire of Esperance

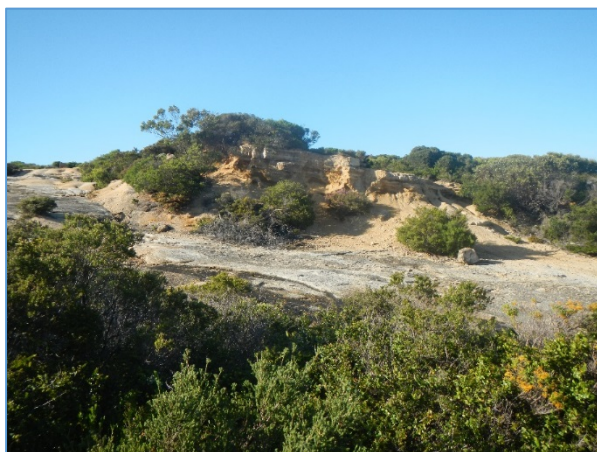
On the western side of Dempster Head there is quite a large area of erosion where vegetation has been damaged or completely removed. Without the plants roots present the thin topsoil over granite has been easily eroded by surface water runoff (Figure 5 and Figure 6).

Figure 5 Topsoil over granite with some vegetation on western side of Dempster Head (view south)

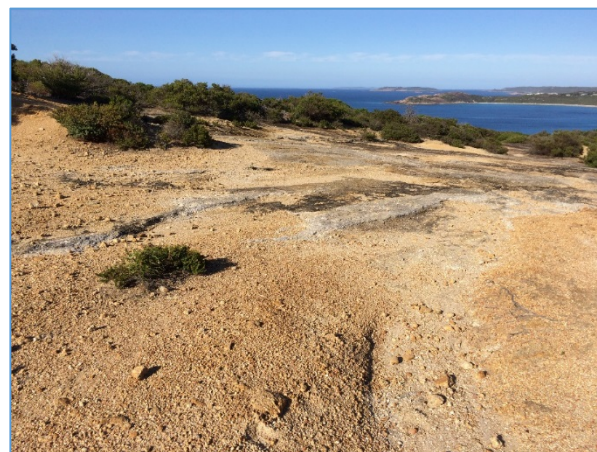
Figure 6 Bare topsoil over granite on the western side of Dempster Head (view south)

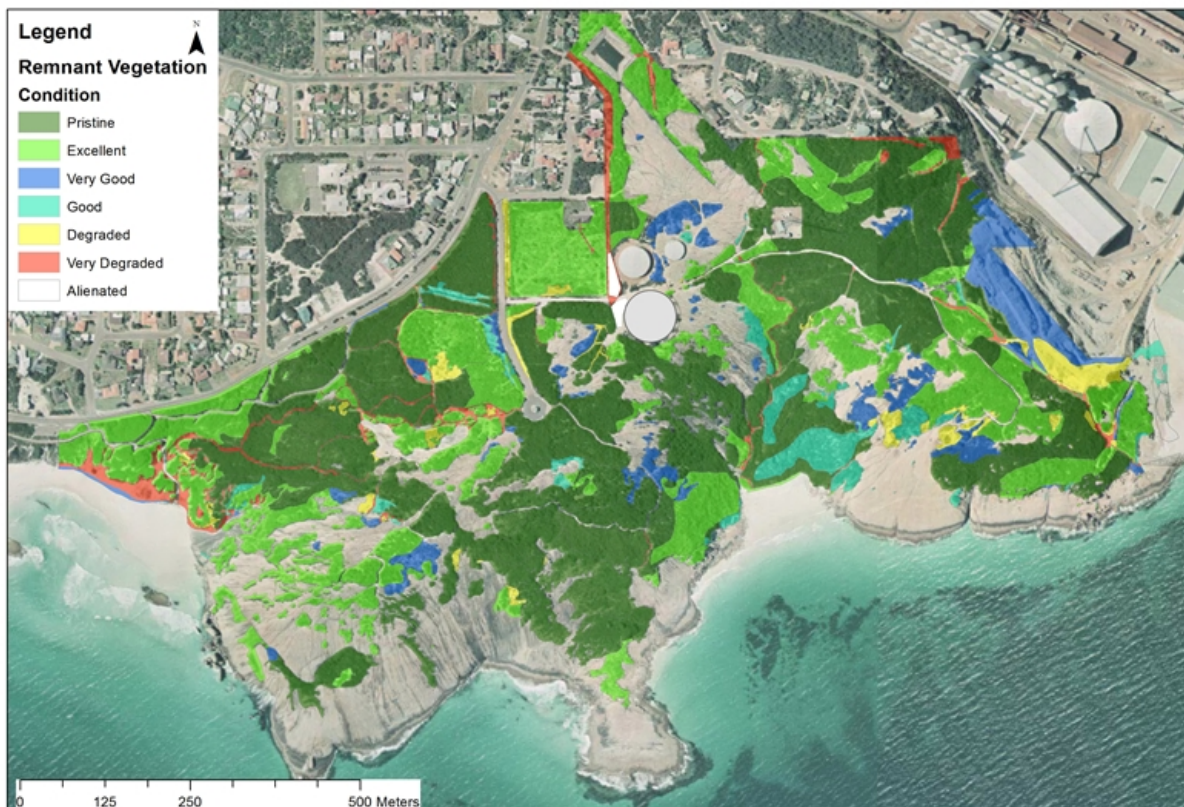
Based on the applied condition assessment method approximately 50% (28.13 ha) of vegetation within the Survey Area is Pristine and a third (18.87 ha) is in Excellent condition (Figure 8 and Appendix A).

Figure 8 Vegetation condition map

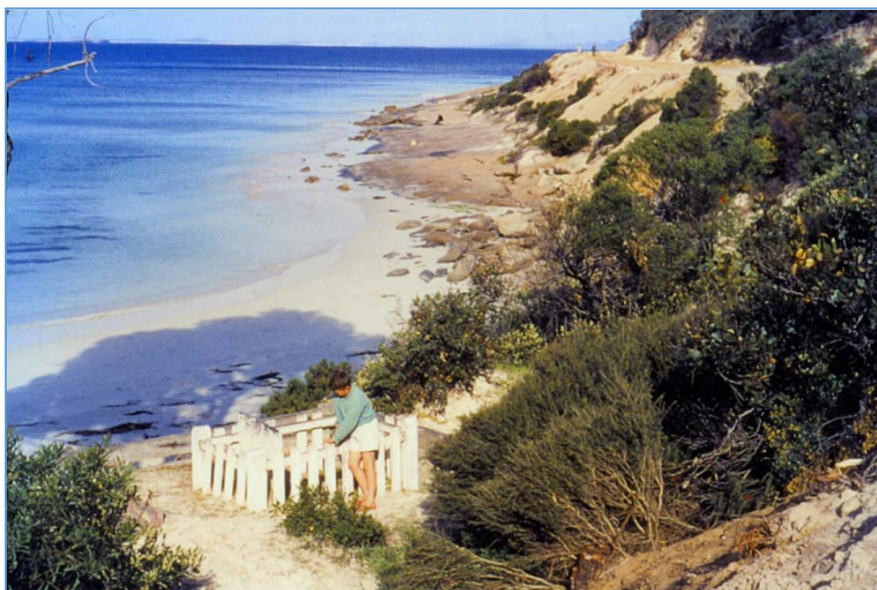
Figure 10 Likely original position of Tommy Windich's grave in 1950s (Past Horizons 2016)

In February 1876 Tommy Windich died of pneumonia in Esperance and was buried in a gravesite with headstone erected by the Forrest brothers, John and Alexander, at the foot of Dempster Head which once lay on the shoreline (Figure 10). Since this time the Esperance Port has expanded with a significant area of reclaimed land and the original headstone is now housed at the Esperance Museum (Past Horizons 2016).

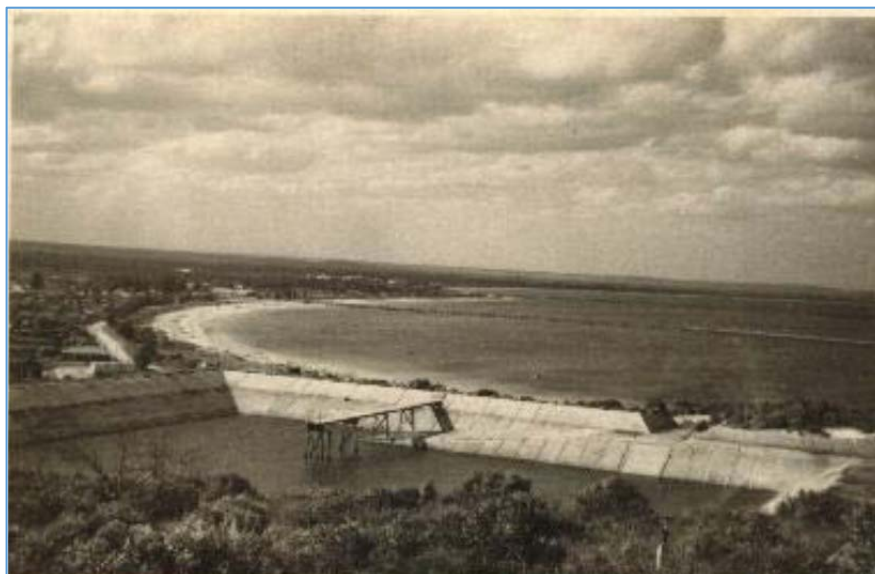
*Figure 11 Old Railway Dam on Dempster Head when in use (Field 2003)*

This water supply was used to service steam trains at the Esperance Salmon Gums Railway until the late 1950's when diesel locomotives replaced the steam trains. Dam construction commenced in 1921 and was completed in 1922 (Figure 11). The Dam catchment is bare granite rock which has been contoured by constructing a rock and cement boundary to channel surface water runoff to the Dam downslope (DPLH 2017).

The Railway Water Supply Dam and Catchment (Place Number 05061), located in the northern part of the Site, is listed on the Shire of Esperance Municipal Inventory as a place of local significance (DPLH 2017). The Dam and Catchment are comprised of land parcels P002788 (Lots 638, 639 and 640) and P005905 (Lots 51, 52, 53 and 54) (Figure 2).

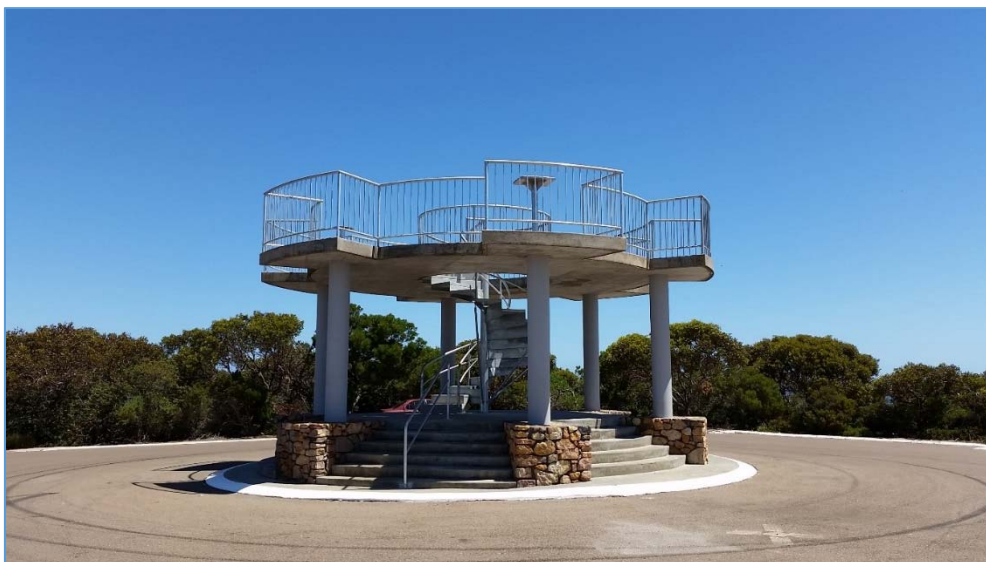
*Figure 14 Current Rotary Lookout following refurbishment in 2017 (view south)*

In 1989 the Rotary Lookout was replaced by the current structure and was recently refurbished in late 2017 (Figure 14).

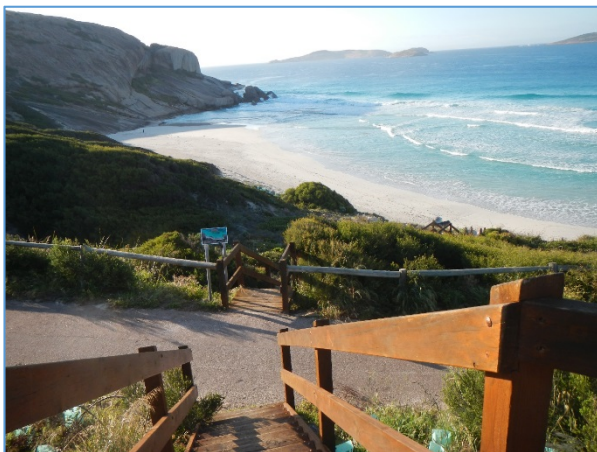
*Figure 15 Wooden steps at West Beach carpark (view southeast)*

Adjacent to the west of the Site is a carpark at First Beach, West Beach which has wooden steps providing access to First Beach and West Beach (Figure 15). Access to Dempster Head is then via informal access up the granite headland to the Dempster Head Reserve via First Beach.

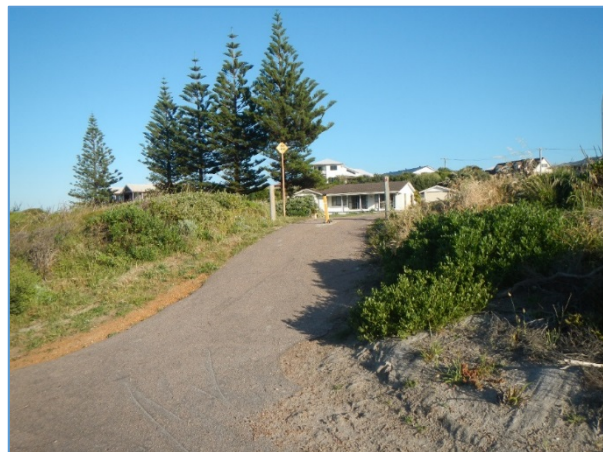
*Figure 16 Emergency vehicle access to First Beach from Twilight Beach Road (view north)*

Emergency vehicle access currently exists from Twilight Beach Road down to First Beach and West Beach (Figure 16). This access is bituminised at Twilight Beach Road and then is a stabilised sand track down to the beach. This access track and surrounding area is subject to periodic erosion following rainfall events.

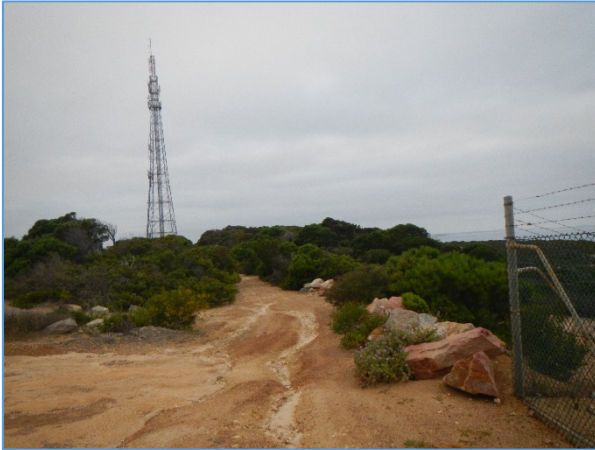
*Figure 17 View north east along track to the telecommunications tower*

Emergency access is also partially available to Lovers Cove from the intersection of McCarthy and Doust Streets, continuing between the Water Corporation water tanks and then follows the track to the south of the telecommunications tower down to the granite (Figure 17).

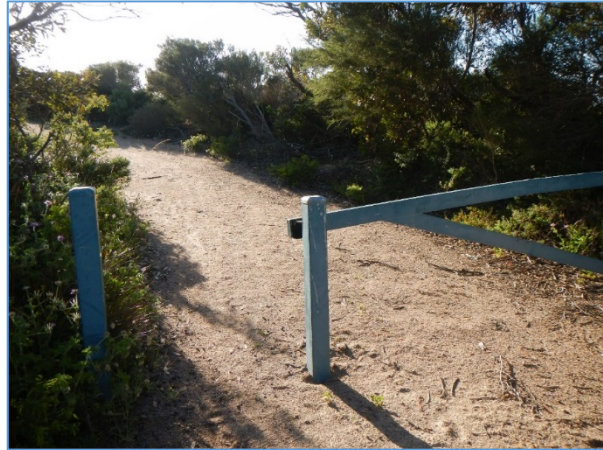
There has previously been access by four-wheel drive vehicles to Lovers Cove however a steel gateway has been installed to limit access to the public (Figure 18).

*Figure 18 Steel gateway installed on the Lovers Cove track*

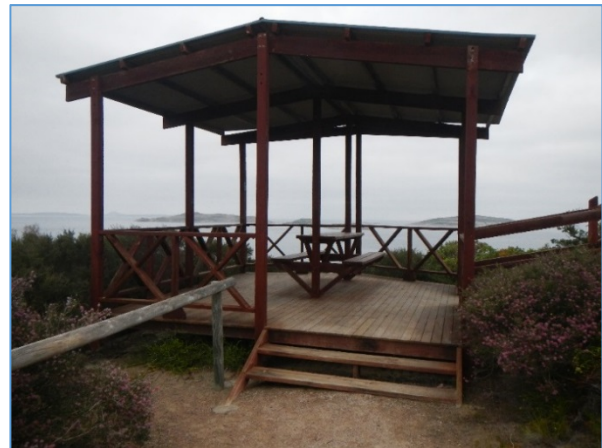
Figure 20 Wooden shelter with table and bench seating (view south)

There is a wooden shelter with table and bench seating which can be used to view the surrounding islands (Figure 20). The trail has wooden steps on steep slopes and raised boardwalks over wet slippery granite (Figure 21 and Figure 22 respectively).

Ongoing maintenance of the wooden shelter and steps is undertaken by the Rotary Club of Esperance and the Shire of Esperance as per their asset management program.

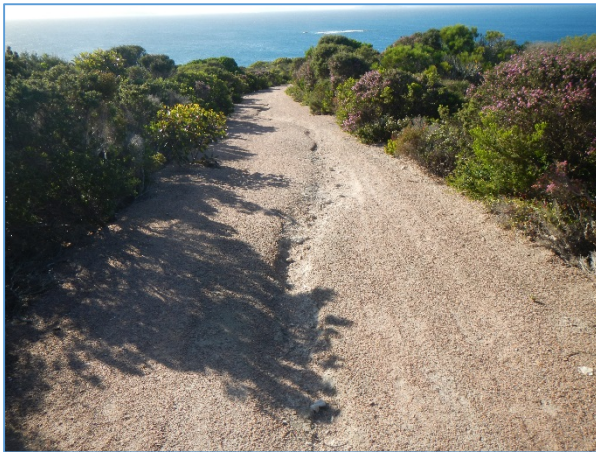
A partially formalised track leads to Lovers Cove from the intersection of McCarthy and Doust Streets, between the Water Corporation water tanks and then follows the track to the south of the telecommunications tower down to the granite (Section 5.1). There is some erosion on this track (Figure 23).

*Figure 23 Track leading to Lovers Cove with some erosion (view south)*

A hand rail has been installed to assist people to access the beach on the steep granite. There is some minor erosion on the formalised access track however the small track at the bottom of the granite has significant erosion and is now a washed out gully (Figure 24). Erosion control measures are required to prevent further degradation of vegetation. Steps from the granite to the beach would also assist with access and help mitigate erosion.

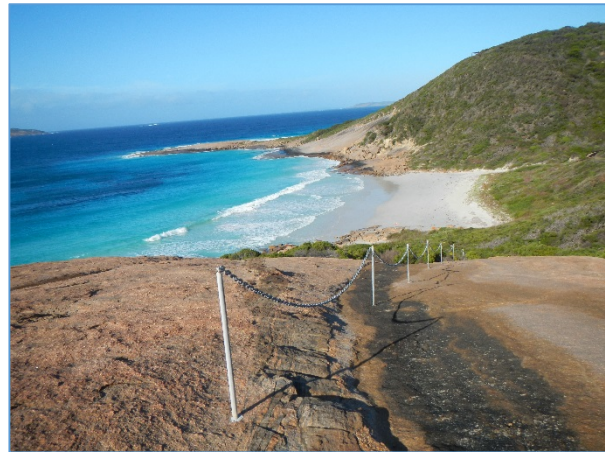
*Figure 24 Hand rail on steep granite to Lovers Cove (view west)*

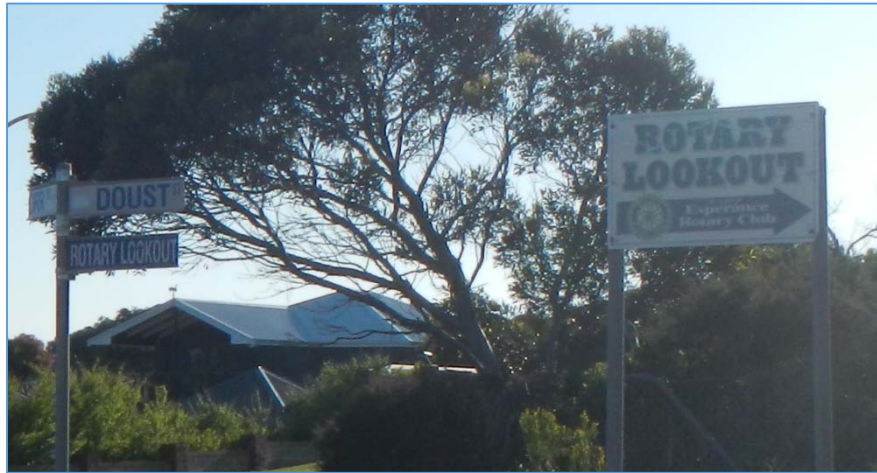
A small entry statement sign is located at the intersection of Twilight Beach Road and Dust Street indicating the Rotary Lookout (Figure 25). However this sign does not provide any information regarding the rest of the Site such as access to Lovers Cove and the Rotary Walk Trail.

Figure 25 Entry statement signage at bottom of Dust Street

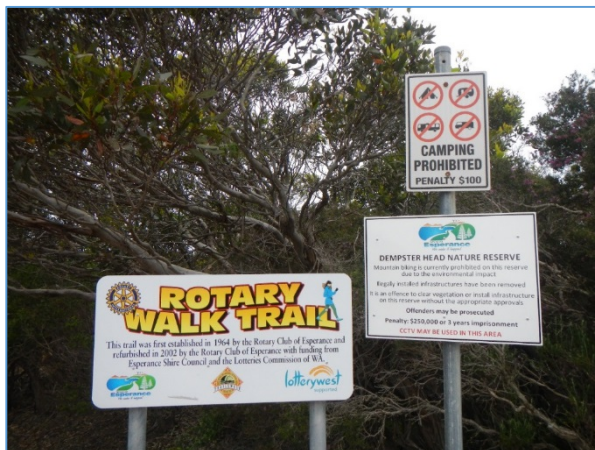
Figure 26 Signage on eastern side of the Rotary Lookout carpark

At the top of Dust Street in the Rotary Lookout carpark there are a number of signs on both the eastern and western sides of the carpark indicating the Rotary Walk Trail and various activities prohibited within the Site (Figure 26 and Figure 27).

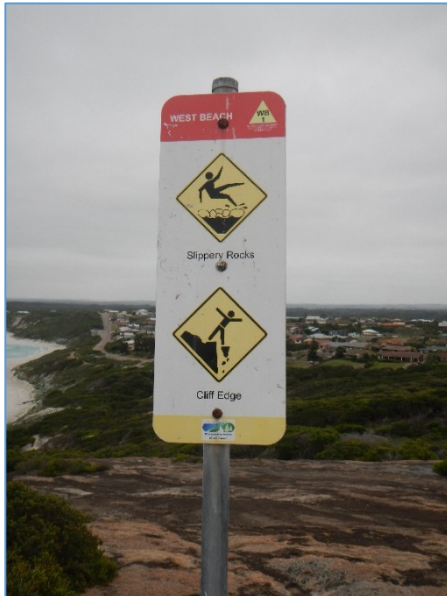
There are two existing warning signs regarding coastal dangers within the Site, both regarding West Beach. There is one located on Dempster Head on the Rotary Walk Trail (Figure 28) and one at West Beach near the carpark (Figure 29).

Figure 28 Safety signage on the Rotary Walk Trail (view west)

There is a need for additional safety signage (similar to the sign at West Beach) at the Rotary Walk Trail and Lovers Cove trail heads warning of coastal dangers, slippery rocks and steep slopes on the walks as per the Surf Life Saving WA report.

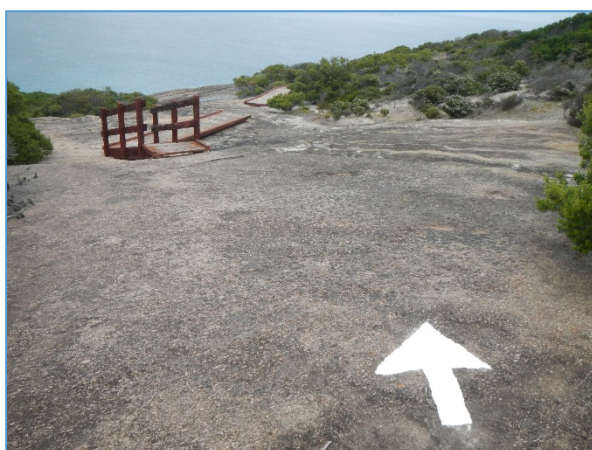
The current trail markers within the Site are inconsistent with white arrows on the Rotary Walk Trail (Figure 30) and white footprints on the Lovers Cove trail to the beach (Figure 31). All formal trails should have consistent names and marking to make it clearer for visitors to stay on the trails and help minimise trampling and damage to vegetation.

Figure 30 White arrow trail marker on the Rotary Walk Trail

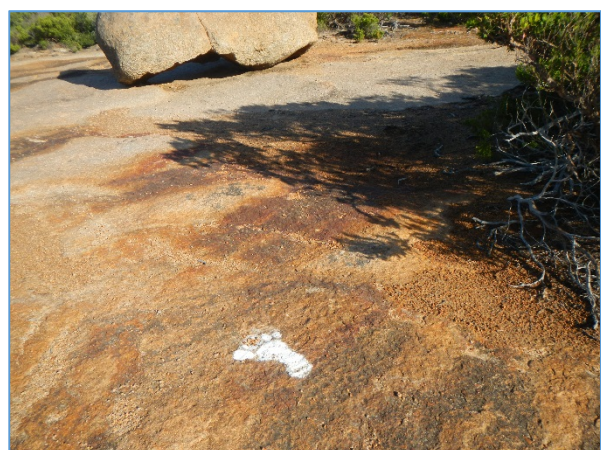
Figure 31 White footprint trail marker on the Lovers Cove trail

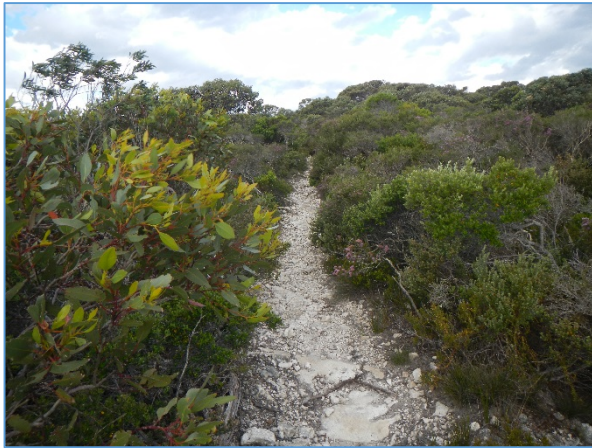
A potential option would be to formalise the existing trail which lies on the western side of the old quarry (Lot 677 Twilight Beach Road). This trail is comprised of relatively stable rocky material (Figure 34) however would require installation of several wooden steps at the junction with the dual use path and some other steep parts of the trail (Figure 35). Erosion control measures would also be required to prevent the trail being washed out and forming a gully as has happened on other trails within the Site

Figure 34 Potential formal trail between dual use path and Rotary Lookout carpark

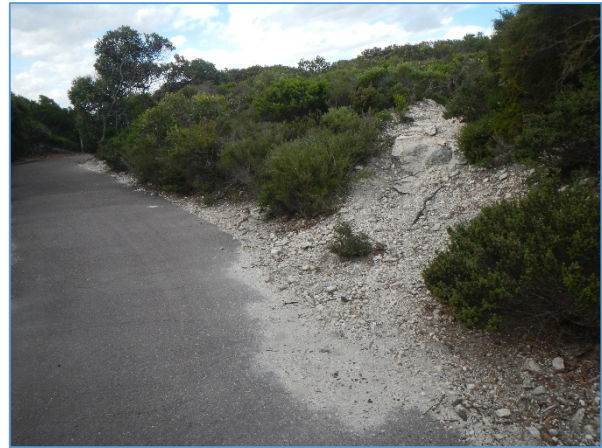
Figure 35 Formalise trail entrance where it meets the dual use path with wooden steps

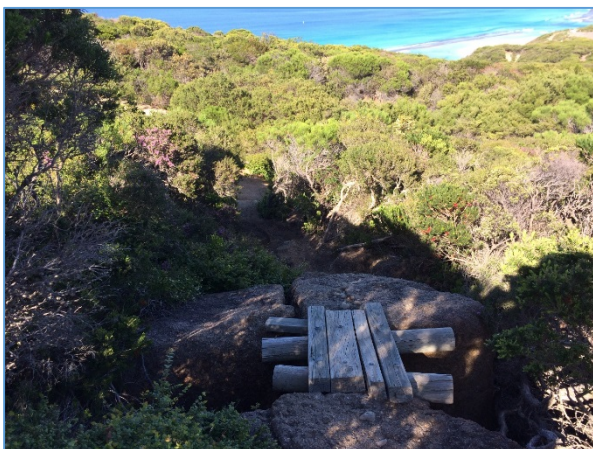
Unauthorised structures used for downhill/ enduro mountain bike riding have mostly been removed however some structures still remain or have been rebuilt since removal by Council (Figure 38 and Figure 39). Downhill/ enduro mountain biking tracks that have been previously constructed do not have alternative routes for varying skill levels as per the requirement of the draft Western Australian Mountain Bike Management Guidelines (WAMBMG) (DPAW 2015).

*Figure 38 Unauthorised structure present on western side of Dempster Head*

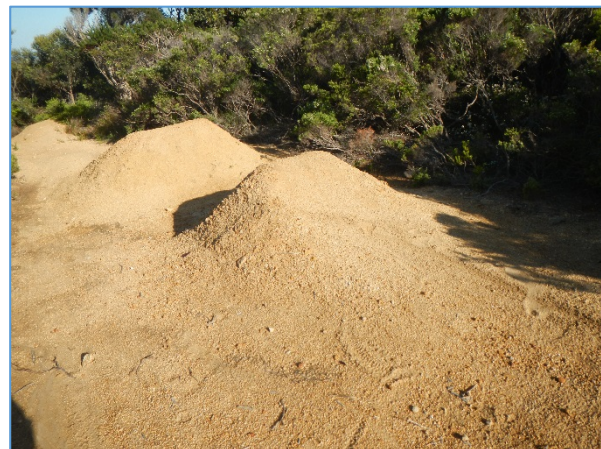
*Figure 39 Unauthorised sand jumps to west of Rotary Lookout carpark*

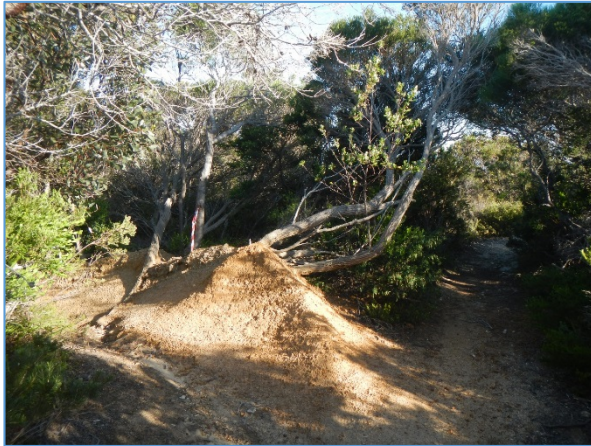
In some parts of the Site, damage to vegetation caused by unauthorised downhill/ enduro mountain bike trail construction (Figure 40) has increased surface water runoff and channelled it towards the western end of the site where there is severe erosion exposing rock and tree roots. Further use of these areas for downhill/ enduro mountain biking in their current state will cause further degradation of vegetation and will further increase the erosion risk (Figure 41).

Figure 40 Vegetation damaged by unauthorised trail construction on western side of Dempster Head

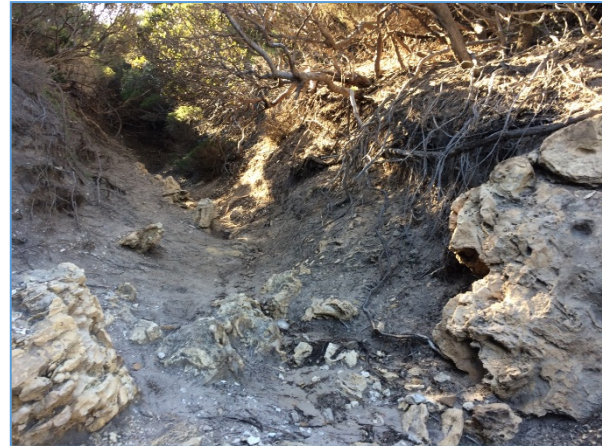
Figure 41 Severe erosion on trail leading to the emergency vehicle access track near First Beach

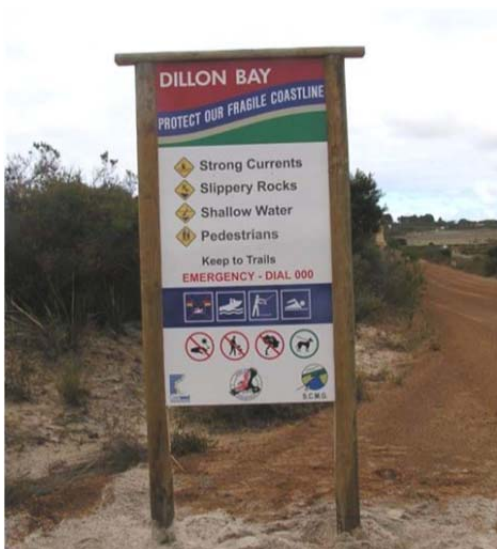
Figure 42 Example of a small trail head sign

The following signs are examples of the types of trail head and information signs that could be used in the Dempster Head area (**Error! Reference source not found.** and **Error! Reference source not found.**). It is recommended that signs and structures used within the Site are constructed as per the Coastal Management Specification Manual (SCMG 2010).
