ESPERANCE BAY

Coastal Erosion Options

Reference: R-J18004.00

Date: July 2018

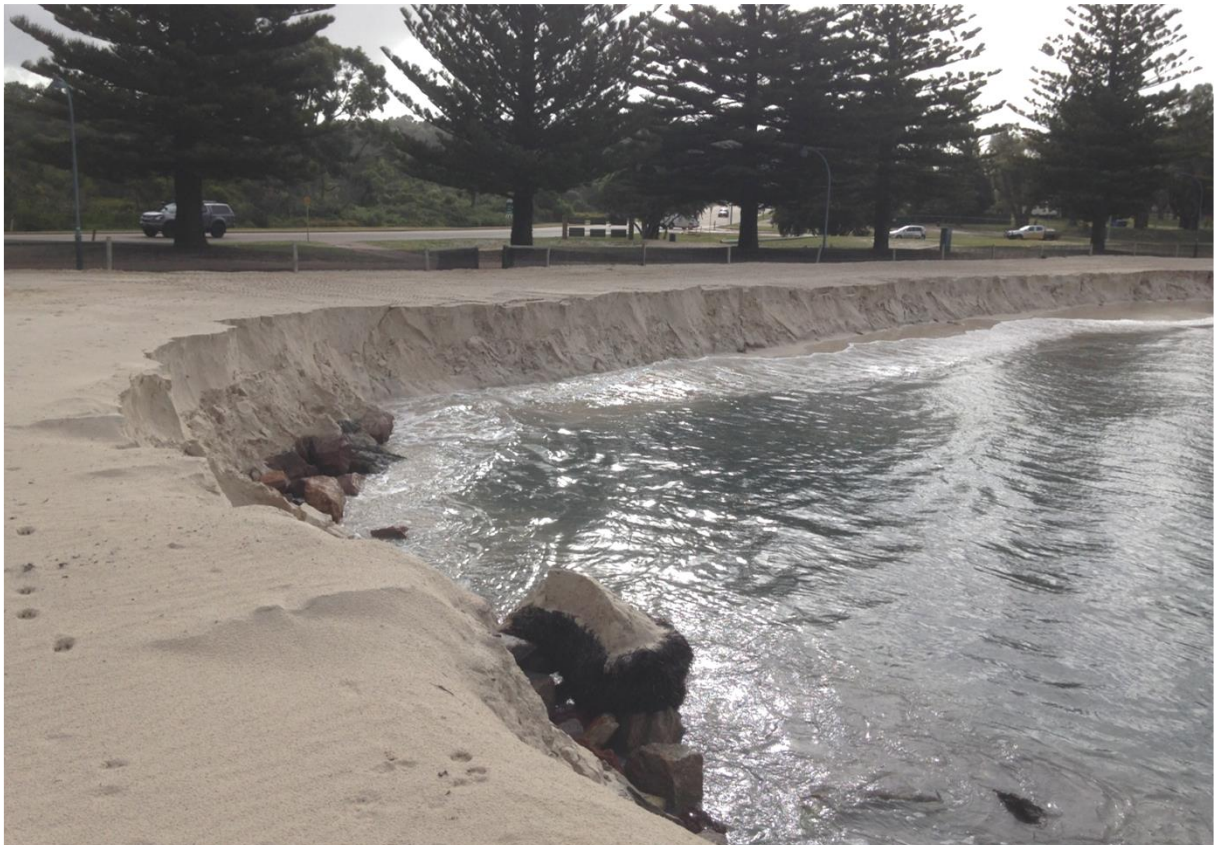
Figure 1-1: Foredune scarp following beach nourishment indicative of high erosion rate at Castletown Beach

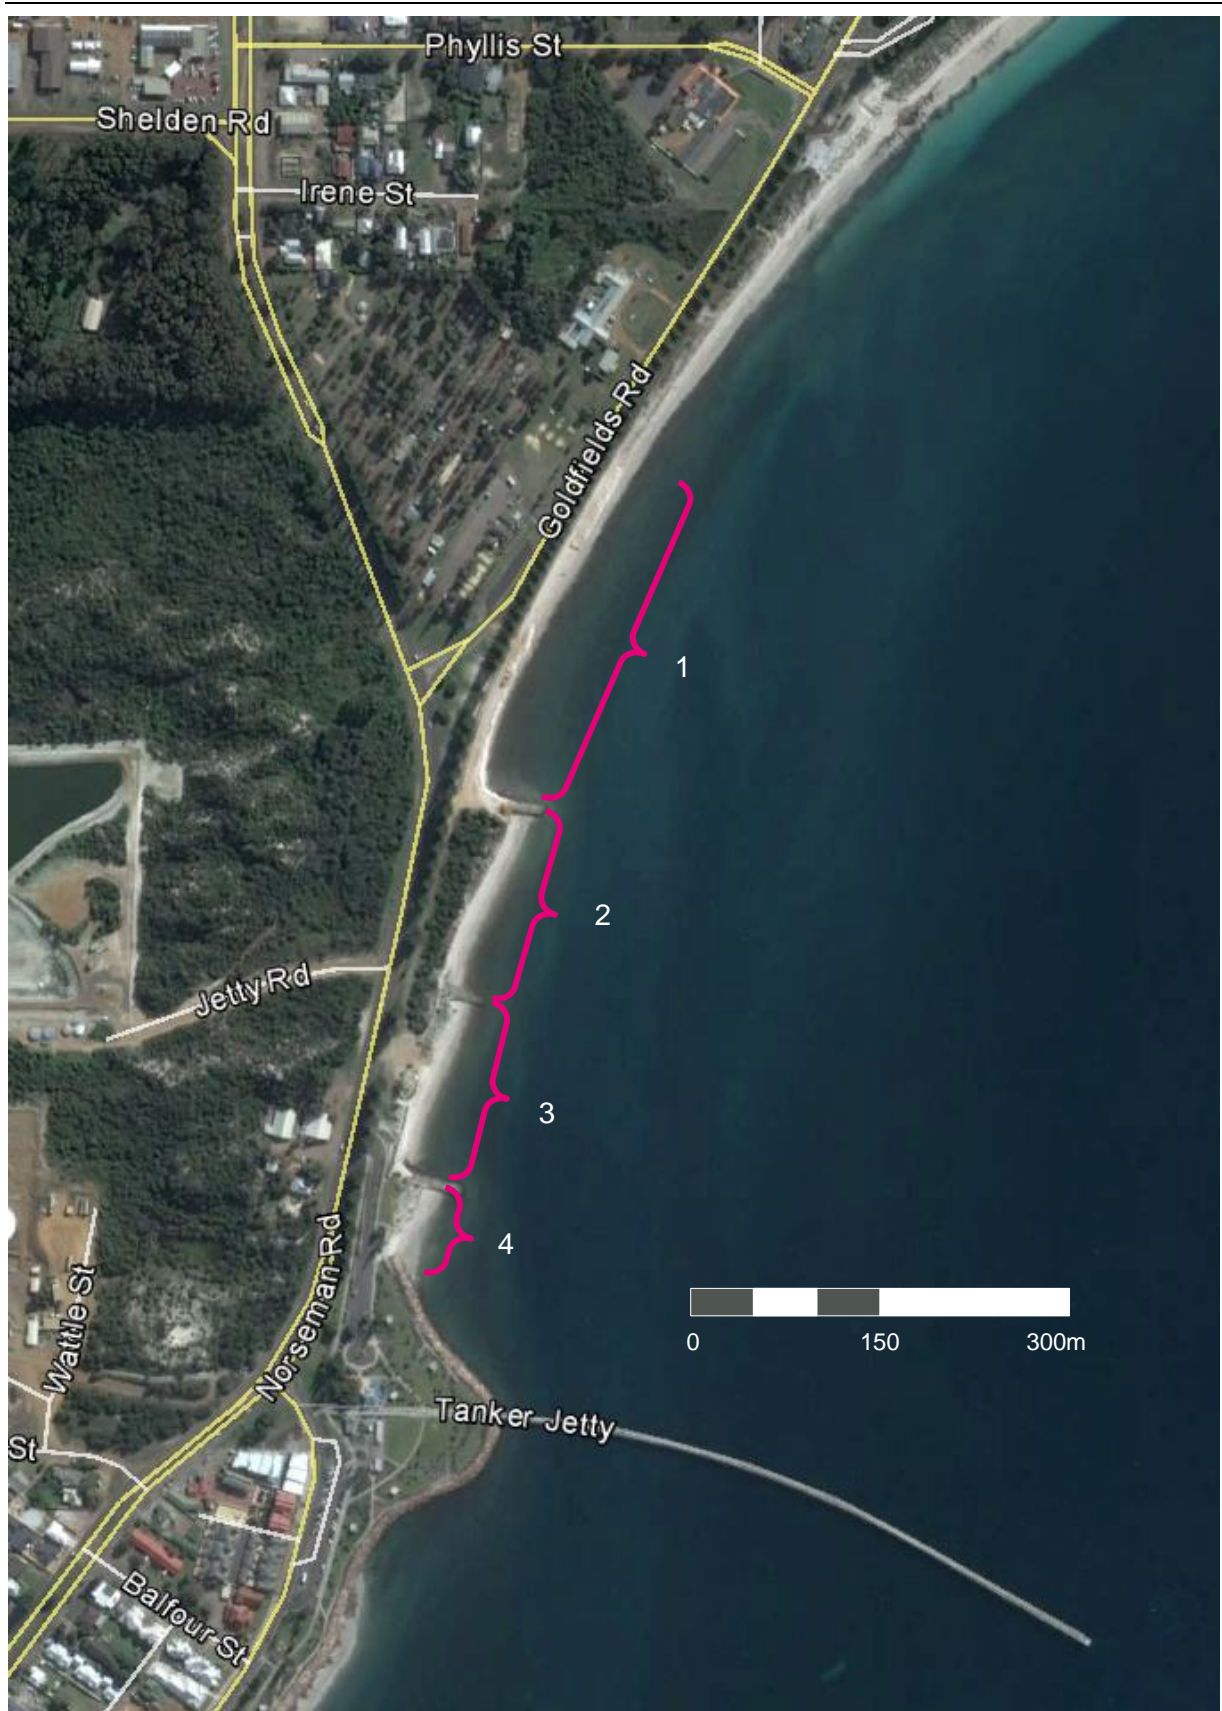
Figure 2-4: Castletown Beach sand nourishment areas

Castletown Beach sand nourishment areas stretches approximately 700m between Esperance foreshore seawall and Esperance YHA hostel and encompasses Norseman Road groyne field (Figure 2-4).

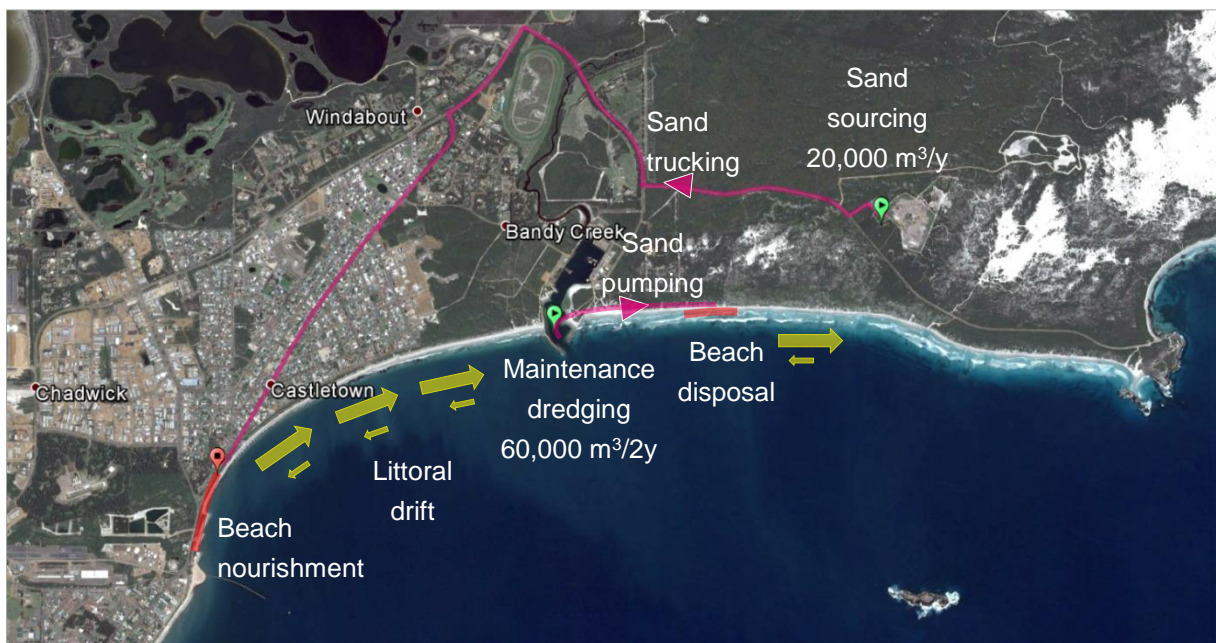
Figure 2-7: Indicative pattern of active sand management in Esperance Bay: Sand “sources” (●), Sand “mechanical” transport (→), beach disposal (-), natural sand drift (→).

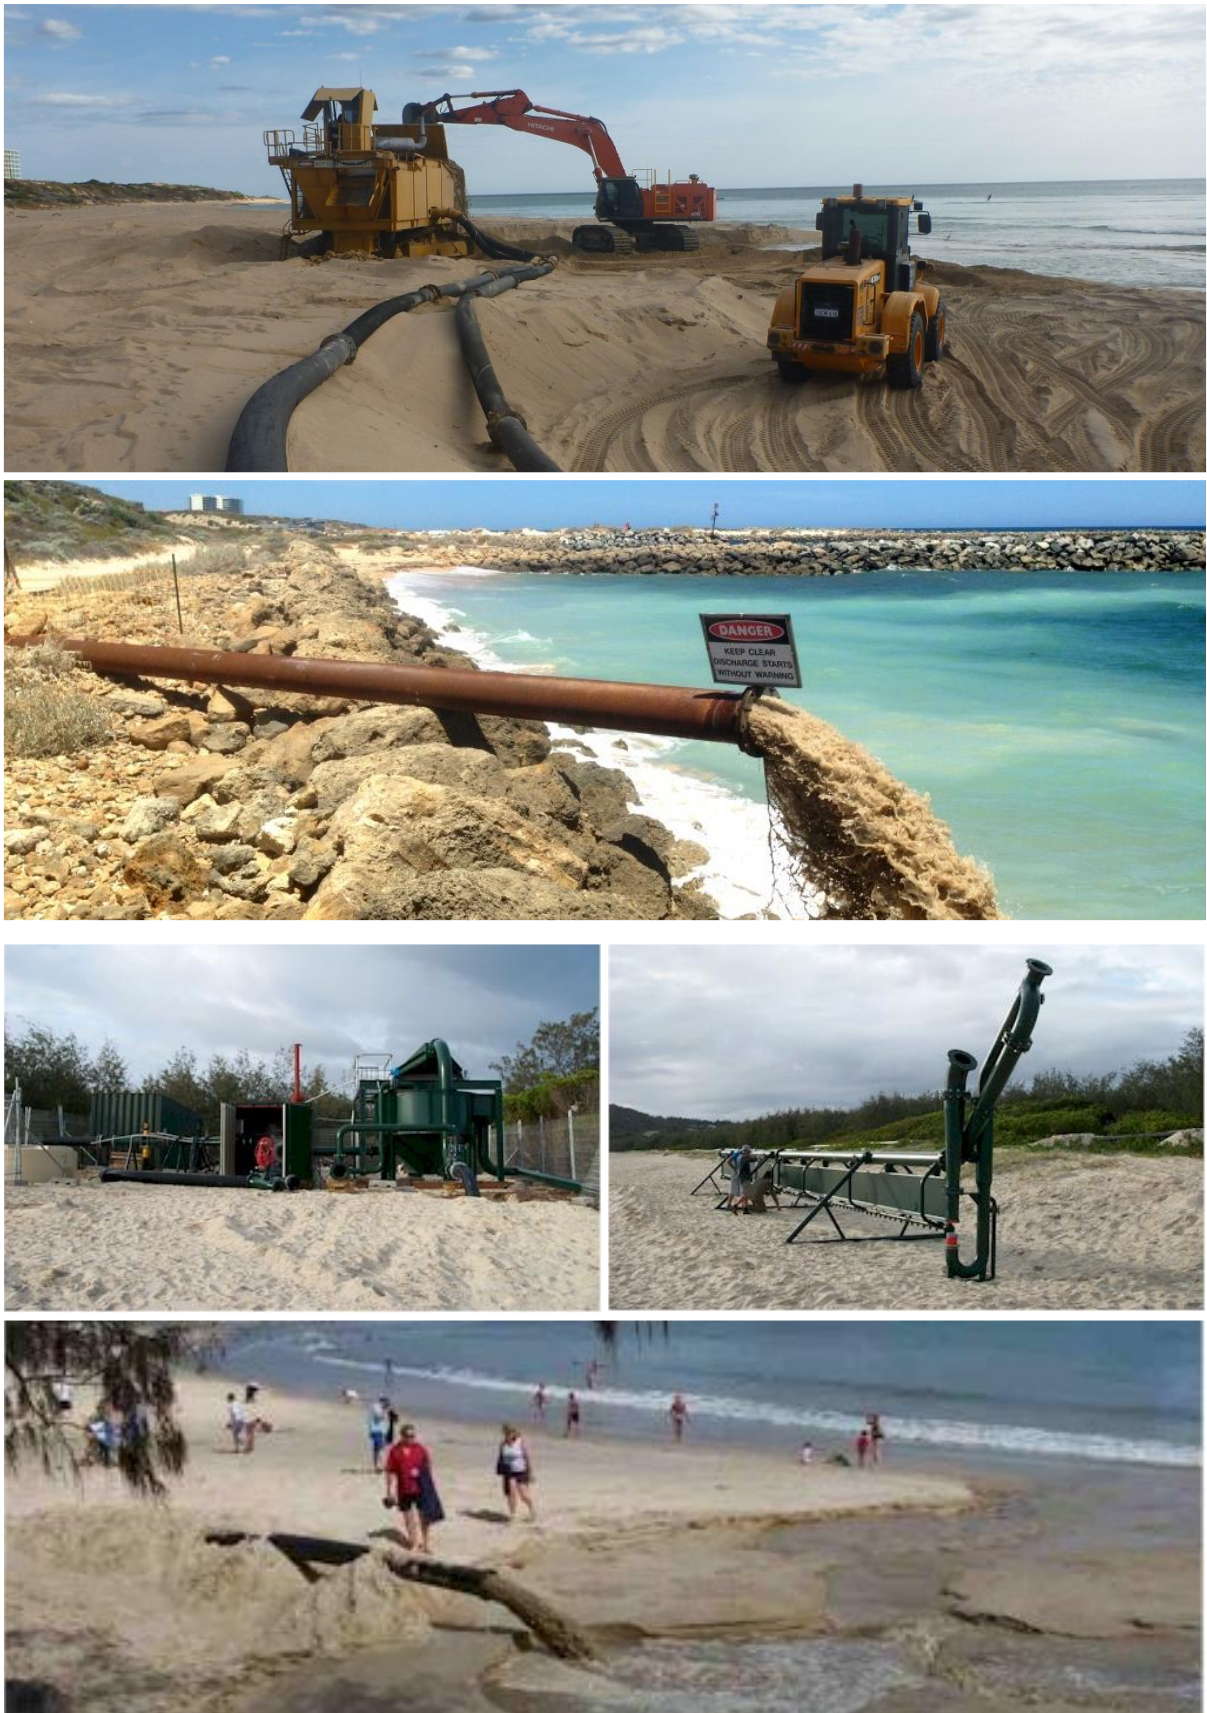
Figure 3-3: Illustration of mobile sand back-passing - Top two: Dawesville, WA (Excavator, mobile slurry trap and discharge pipeline). Bottom three: Noosa, QLD (Pump station, sand shifter and discharge pipeline).

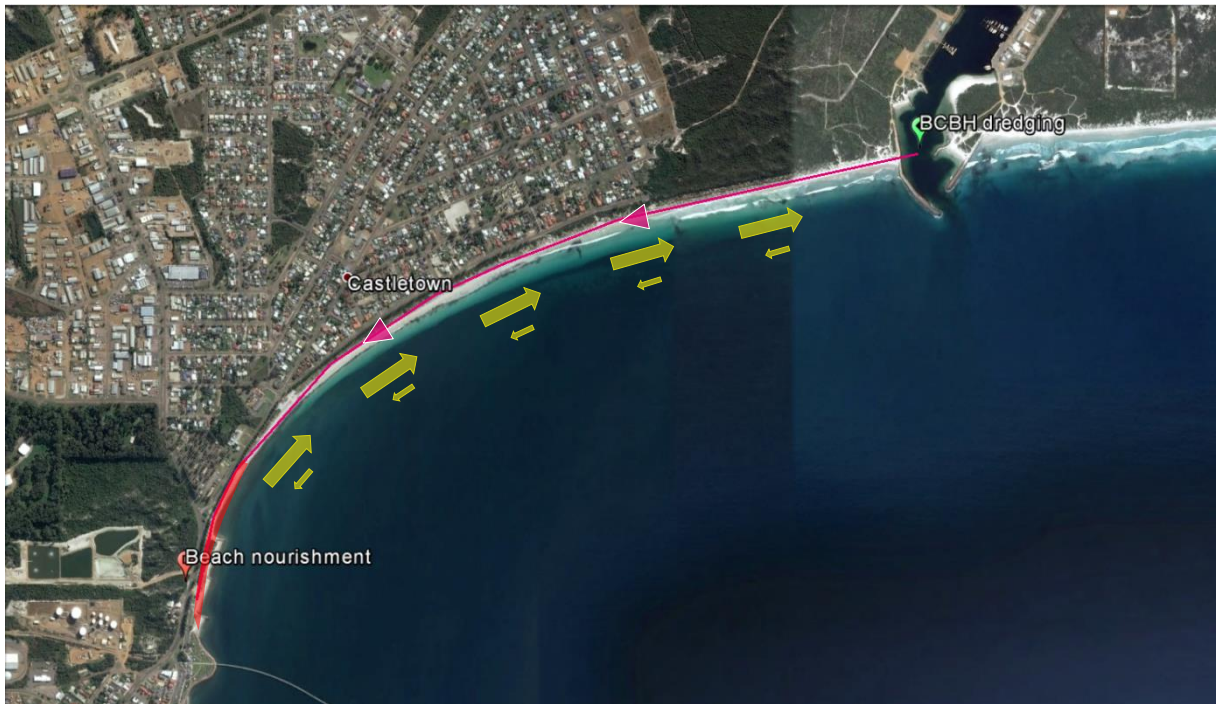
Figure 3-5: Indicative pattern of sand management for coordinated sand back-passing: Sand “sources” (●), Sand ”mechanical” transport (➔), beach disposal (-), natural sand drift (➔).

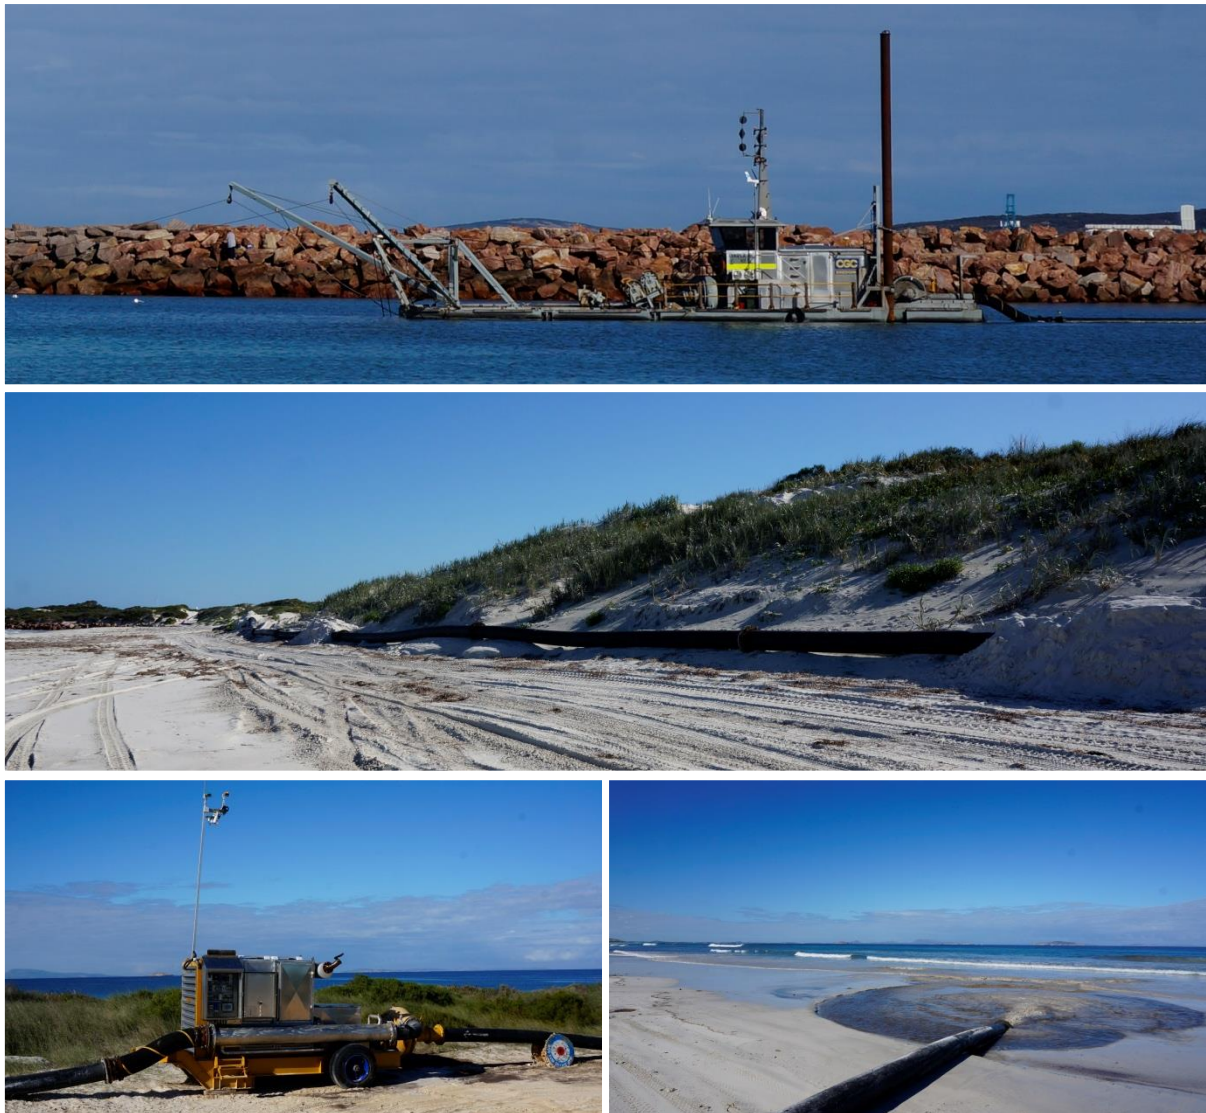
Figure 3-6: Illustration of dredging and beach disposal at Bandy Creek Boat Harbour (dredge, slurry pipeline, booster pump and discharge pipeline).

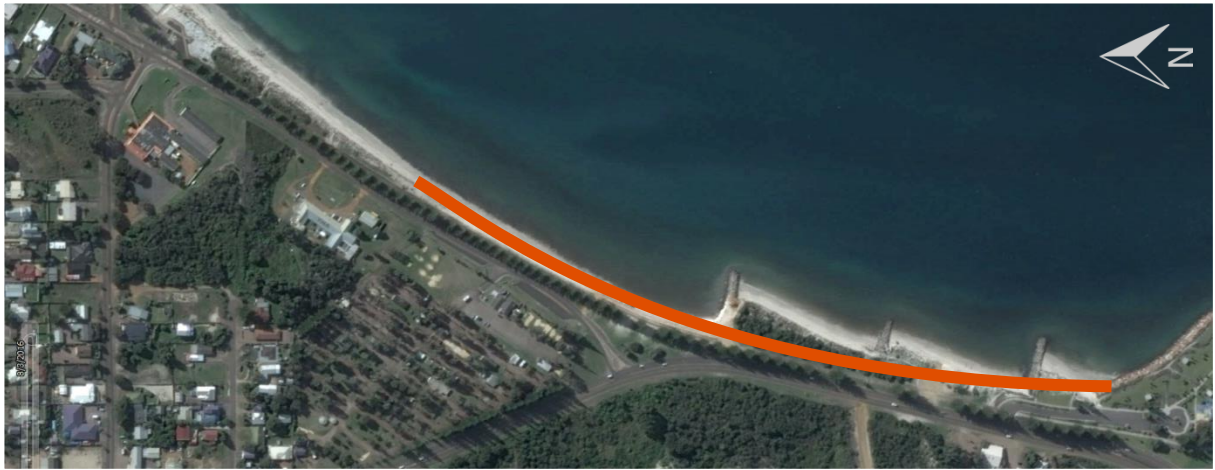
Figure 3-7: Indicative alignment of seawall (—).

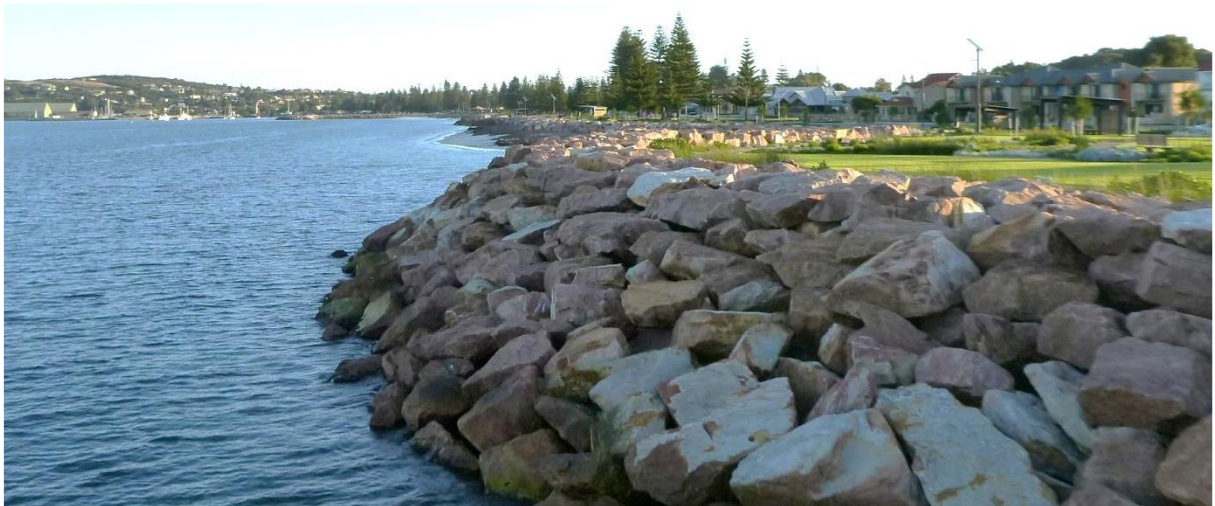
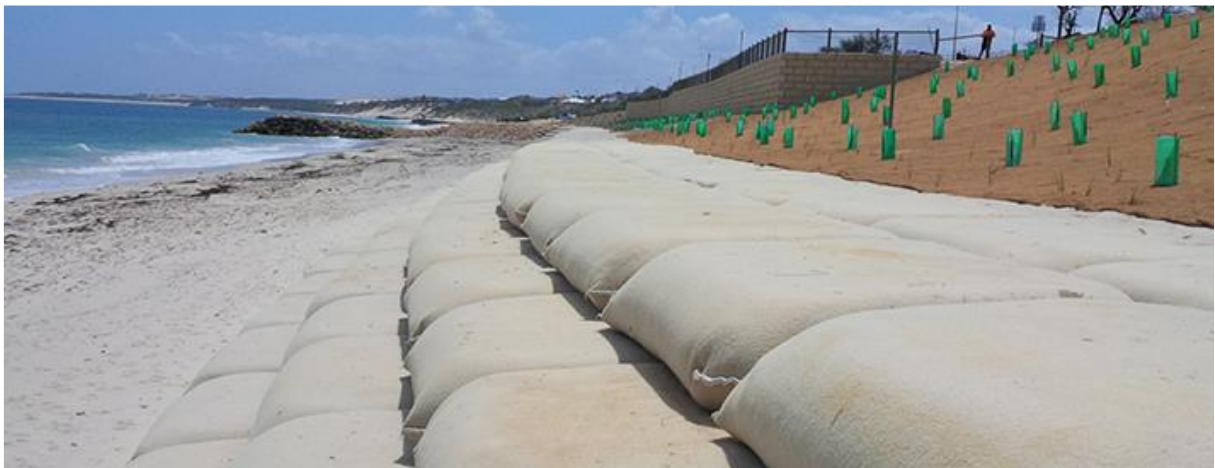
Figure 3-8: Illustration of seawall options – top: Esperance Foreshore, WA (rubble-mound seawall); bottom: Quinn’s Beach - Wanneroo, WA (geotextile seawall, photo credit: <http://www.tessilbrenta.com>).

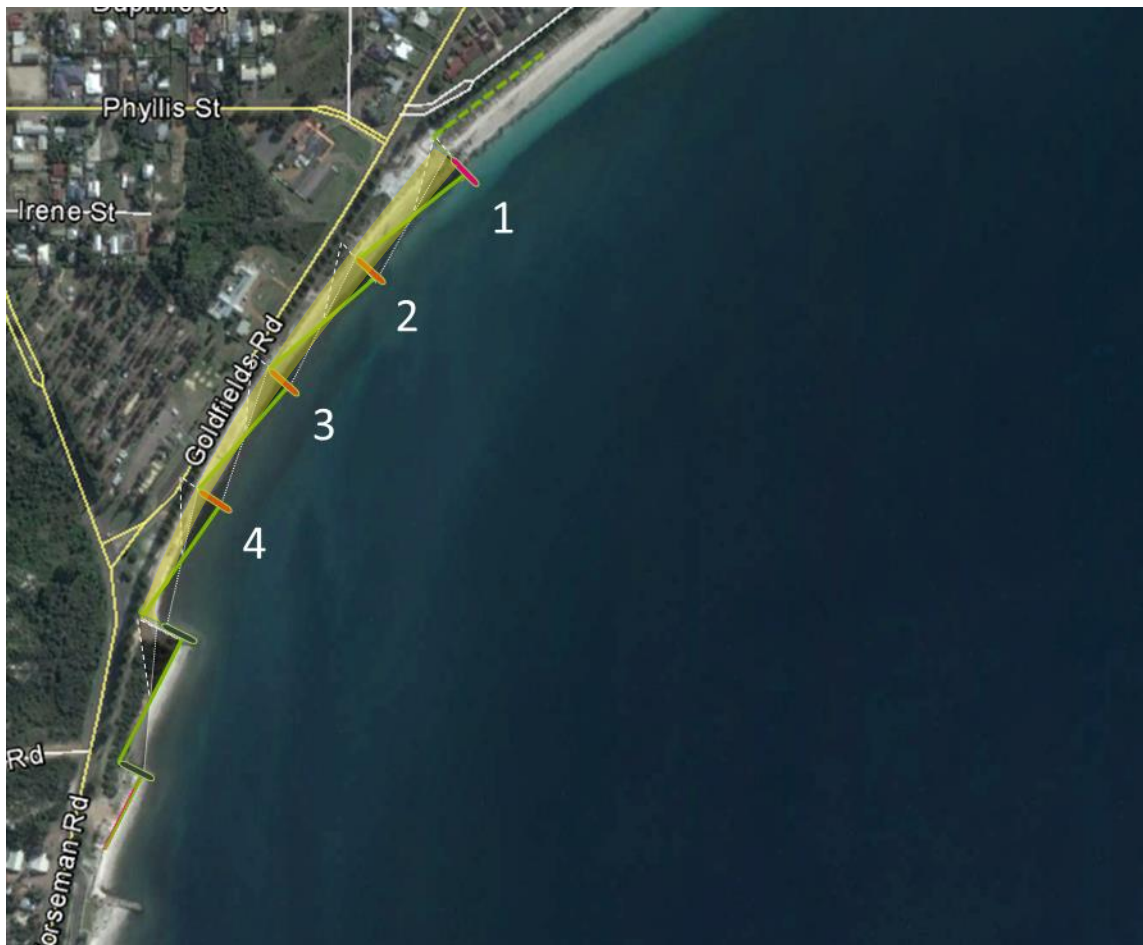
Figure 3-10: Illustration of Option 5 – Groyne(s) – 4 short groynes.

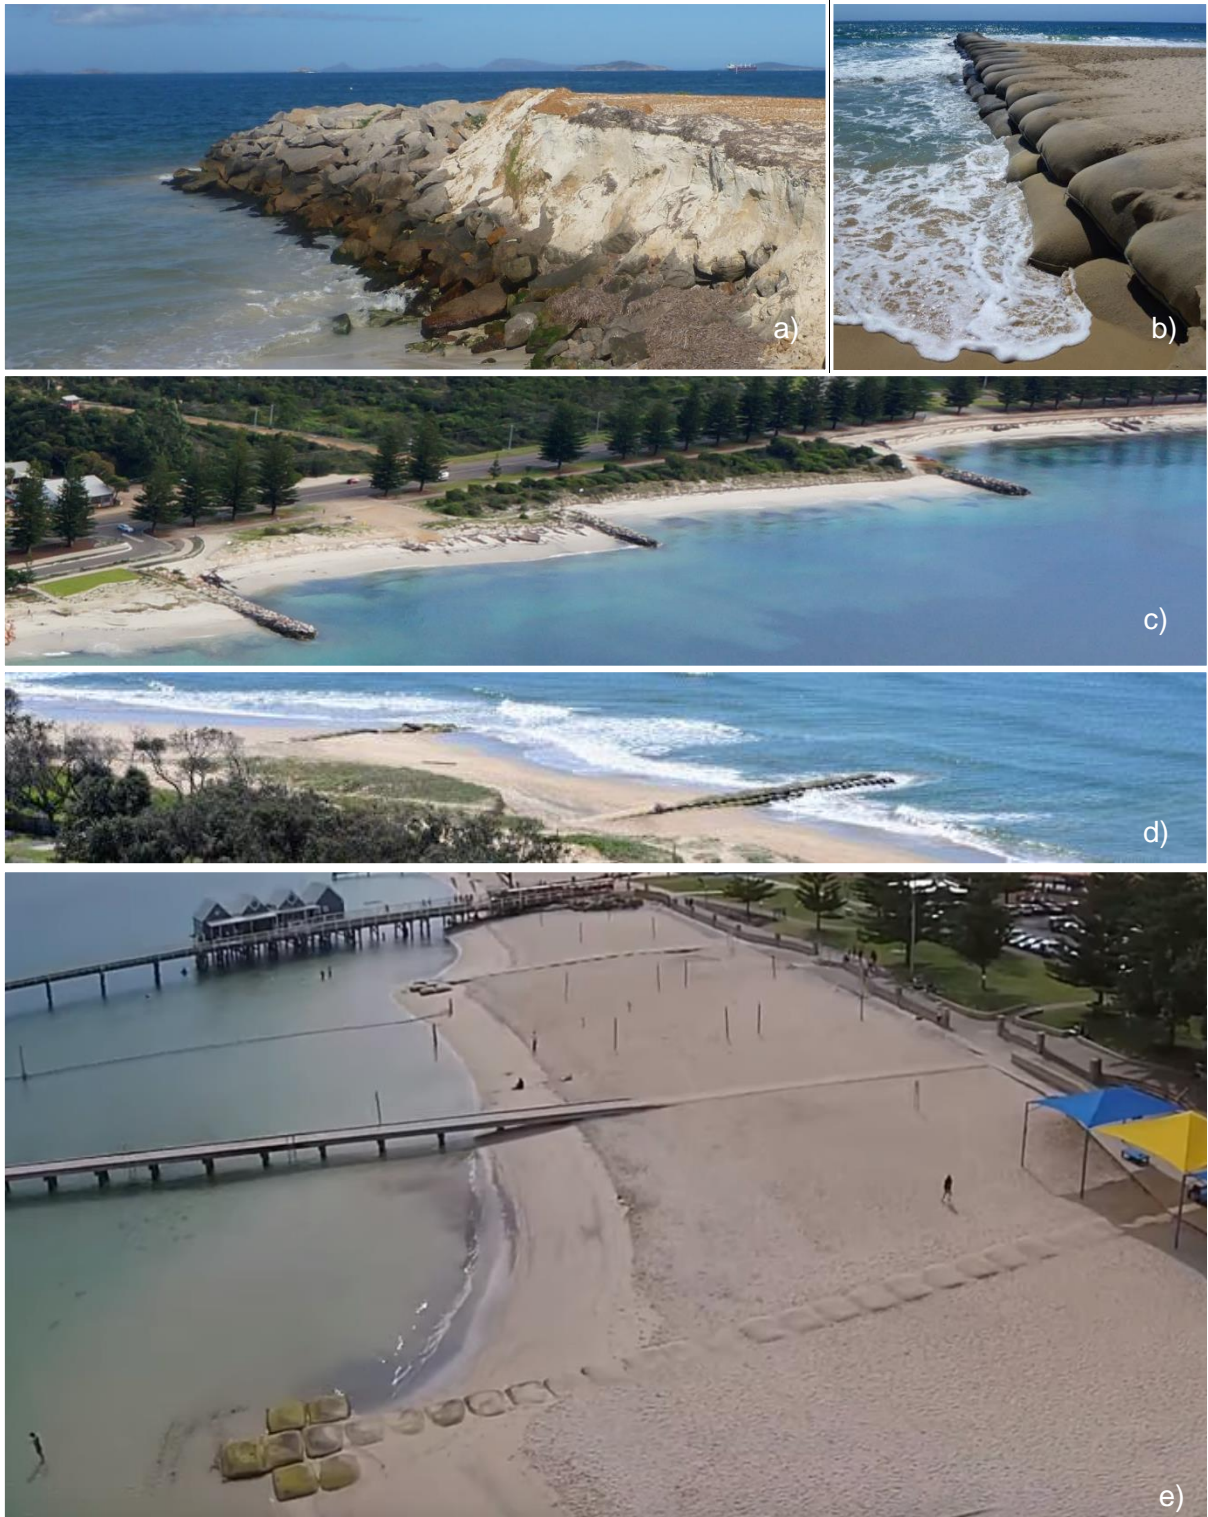
Figure 3-11: Illustration of groyne options: Rubble-mound groynes Esperance Norseman Rd, WA (a,c); Geotextile groynes: Busselton, WA (e) Maroochydore, QLD (b,d). Photo credit: Hilary Darmody (b,d) and Andrew Mozdzen (d).

An alternative to these large groynes options is the use of short groynes to continue the existing groyne field. The erosion downstream of the terminal groyne is controlling the length the field, to such location as sufficient dune buffer is available. It should be noted that beach nourishment may be required from time to time between the groyne to replenish the beach after large storm events, as sand is being transport away from the sediment cell formed between two groynes. This kind of options are illustrated Figure 3-11.

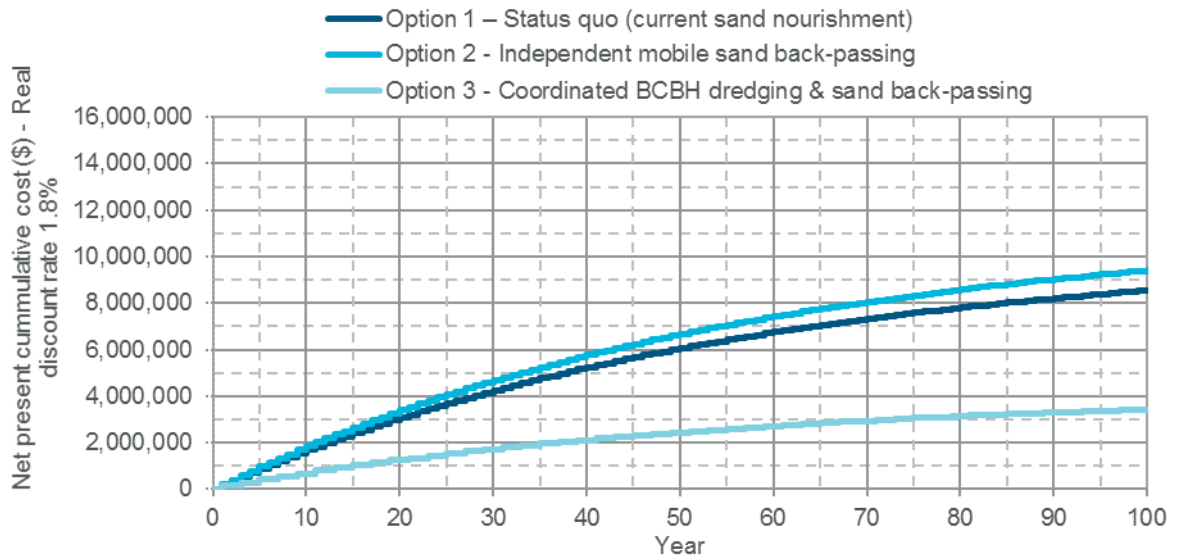
Figure 3-12: Discounted cumulative cost for Option 1 – Status quo (current sand nourishment), Option 2 - Independent mobile sand back-passing and Option 3 - Coordinated BCBH dredging & sand back-passing.

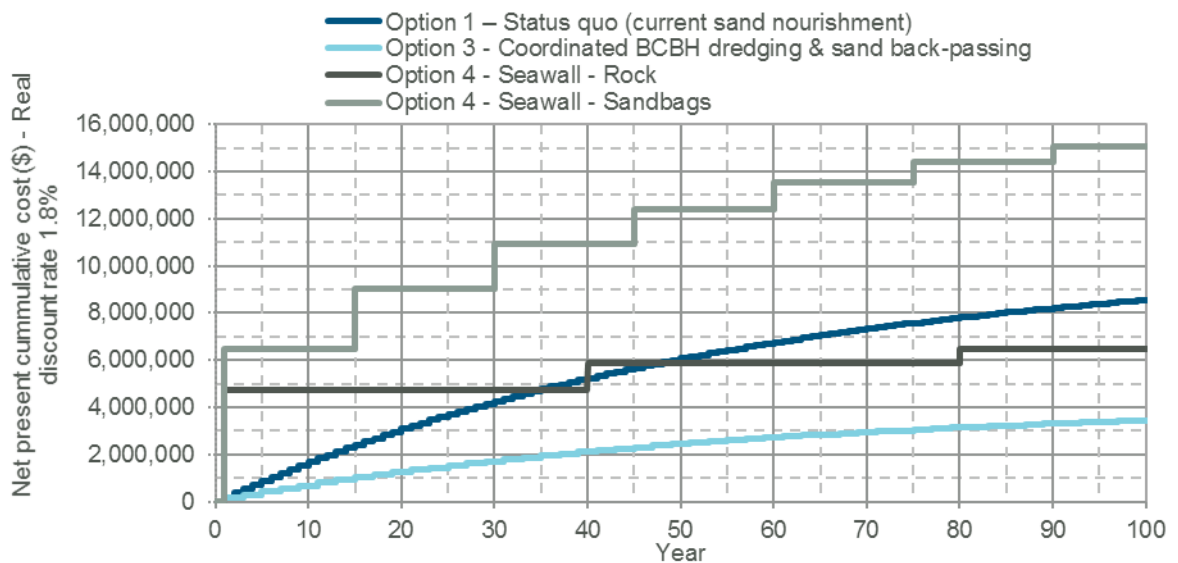
Figure 3-13: Discounted cumulative cost for Option 4 - Seawall – Rock and Sandbags

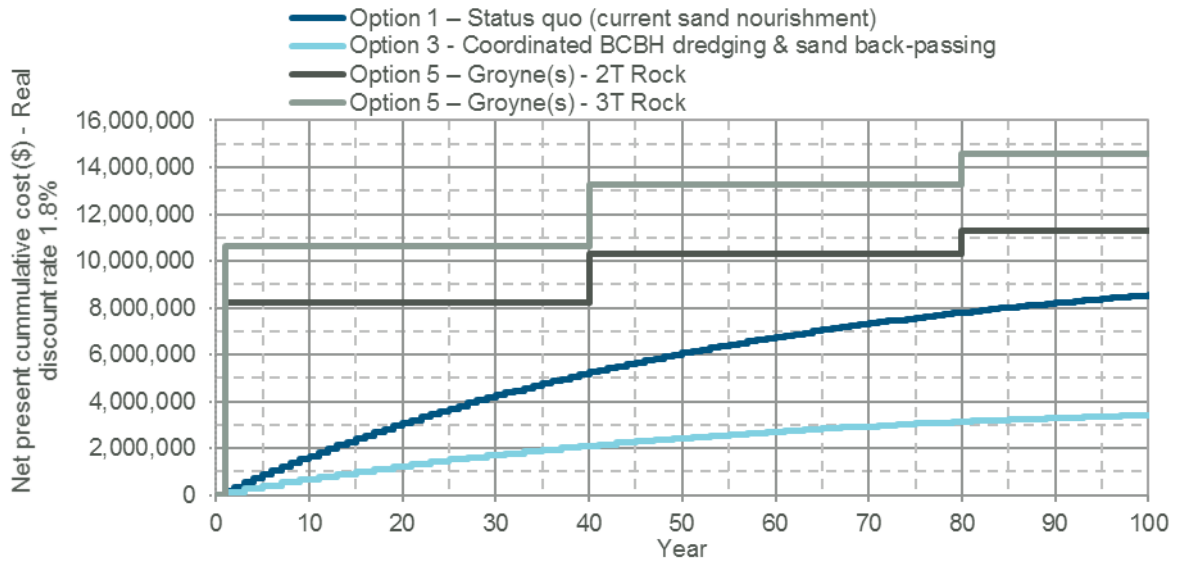
Figure 3-14: Discounted cumulative cost for Option 5 – Groyne(s) – 2T and 3T Rock.
