Tanker Jetty, Esperance Remediation Report

Prepared for
The Jetty Group Incorporated

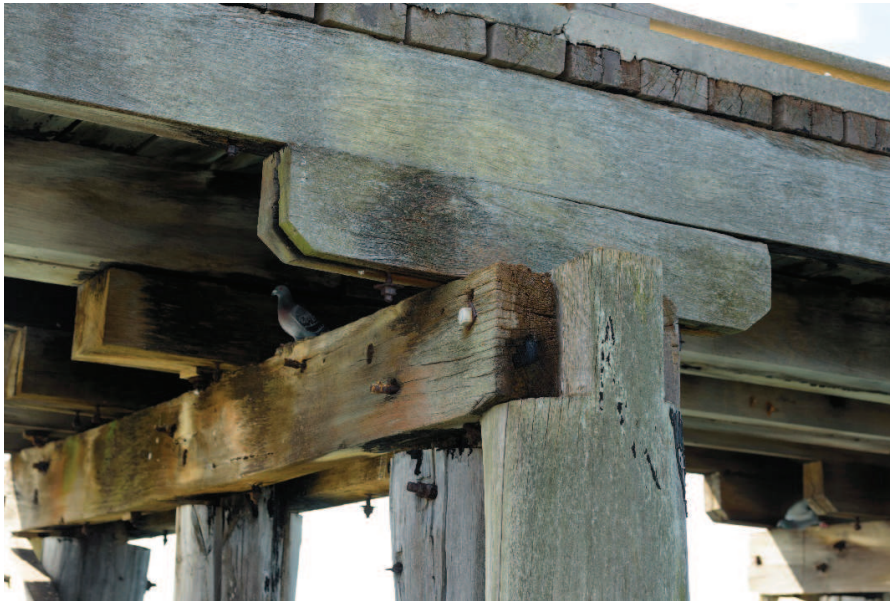
Below is an image of a typical bent, showing the piles, headstock beam (connected to the pile via the halfcap joint), the timber corbel on the headstock and the stringers above the corbel. This particular image also shows one of the very few bents that still have the original (1935) central timber piles still attached.

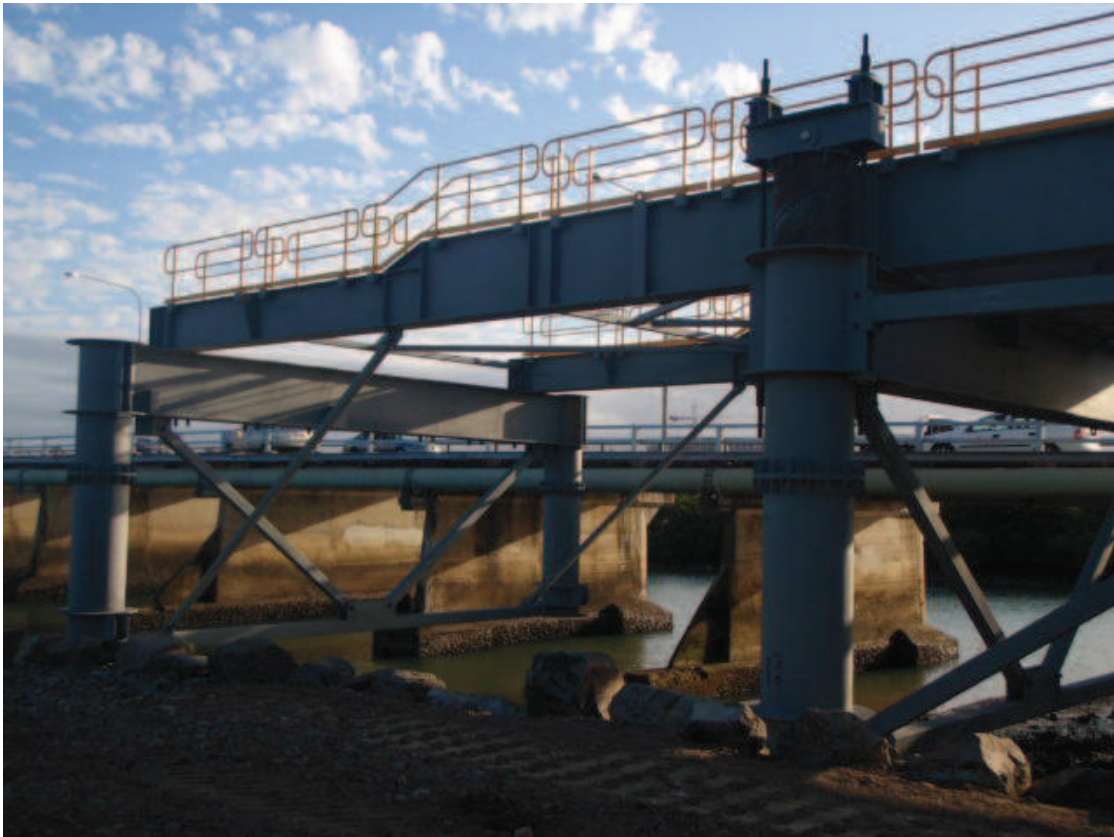
Figure 3: Example of a previous program in which piles were driven through a suspend headstock.

For the Tanker Jetty it is impossible to slide the new headstock over the previously driven piles because the headstock must be fitted under the existing Jetty. The logical solution is therefore to drive the piles through the sleeve and therefore the headstock assembly must be secured to the Jetty prior to pile installation. I have previously designed a system just like this for the construction of a 140m long temporary bridge in Mackay, Queensland. Below is an image of the suspended headstock frame, complete with sleeves, prior to the piles being inserted (into the sleeves) and driven. In the image below the penultimate bent has the completed pile installed plus a rod suspension system for level adjustment.
